**TEST REPORT:**  
**HIGH CURRENT ARC ENTRY TESTING ON**  
**CSST GAS TUBING SAMPLES USING LC1027 & LC1024 METHODS**

Marquette Wolf  
Ted B. Lyon & Associates, P.C.  
18601 LBJ Freeway, Suite 525  
Mesquite, TX 75150

22 April 2013

Lightning Technologies,  
an NTS Company  
10 Downing Industrial Parkway  
Pittsfield, MA 01201-3890  
U.S.A.

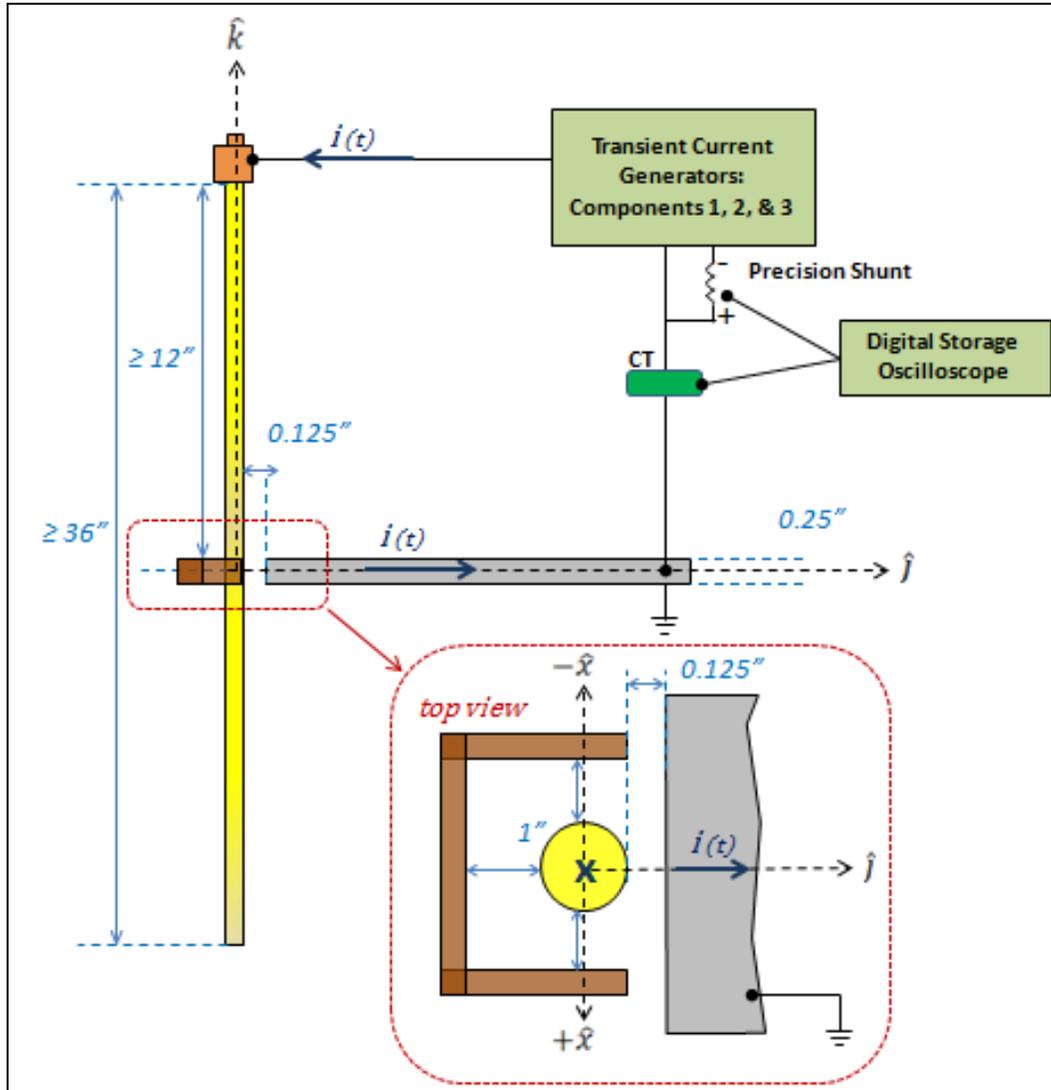
Figure 1 – General Setup Diagram for LC1027 “Arcing Resistance, Direct Effects” Tests

The first tests performed on the Titeflex, Gastite CSST test samples as well as on a section of 0.75” sized black iron pipe were the arc entry tests described in LC1027. This setup involves orienting the test pipe sample vertically, with one end of the pipe connected to the output of the current transient generator. The pipe is then positioned such that one side is within 0.125 inches from the edge of a 0.25 inch thick grounded plate electrode, which serves as the transient generator’s current return. The arc is then established between the pipe and the edge of the grounded plate, with the other three sides of the pipe ‘boxed’ in with non-conductive supports, spaced one inch from the pipe surface. This test procedure only requires that one end of the CSST test sample be terminated with the manufacturer’s end fitting. Figure 1 shows a basic cartoon of this test arrangement, with Figure 2 showing a photograph of the calibration setup. Figure 3 shows a photograph of the test setup using the black iron pipe sample and typical setups for the conductive and non-conductive jacketed CSST gas pipe samples are shown in Figures 4 and 5, respectively. Figure 6 shows the single CSST test performed with the gas pipe volume filled with propane gas. Figure 7 shows the single CSST test conducted with the gas pipe volume filled with propane gas, and pressurized.

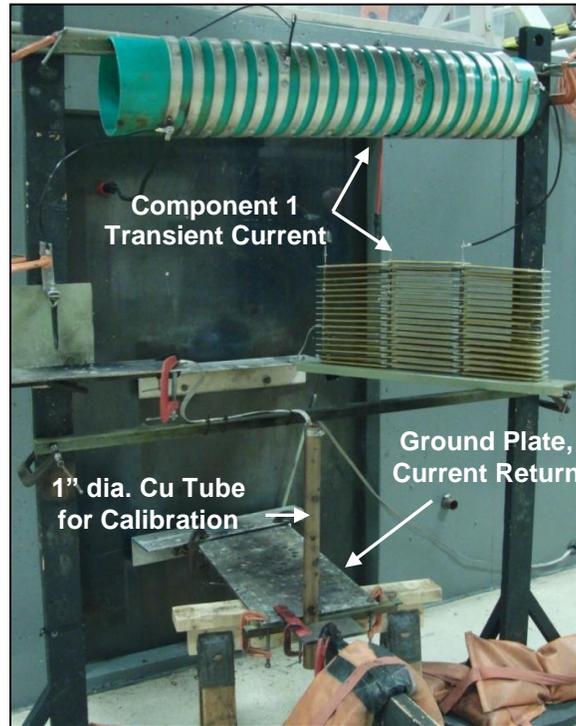
Figure 2 – Photograph of Setup for LC1027 “Arcing Resistance, Direct Effects” Tests

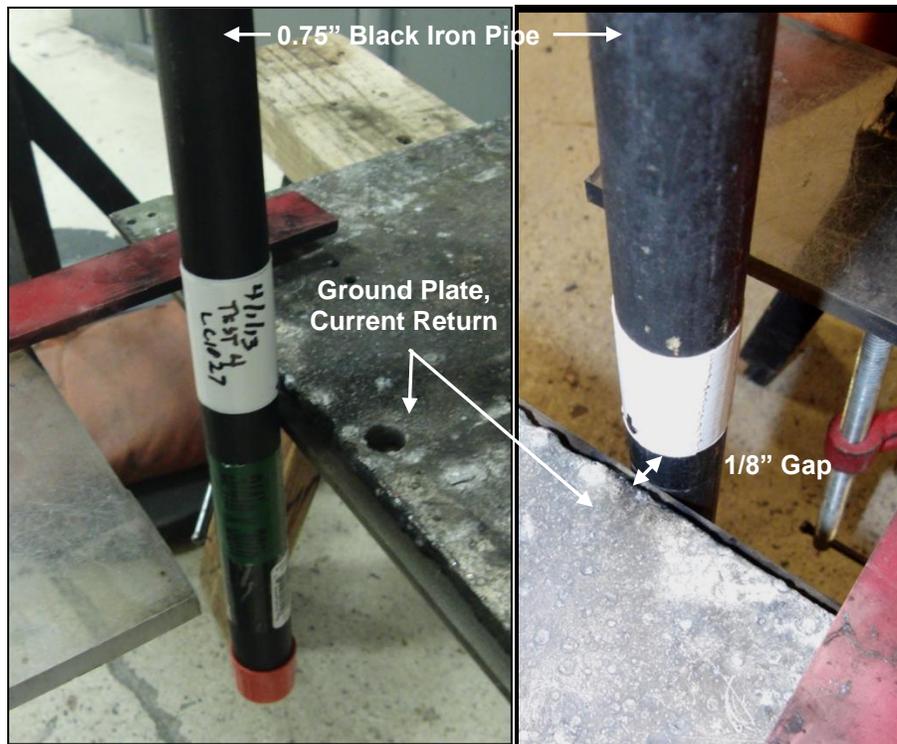
Figure 3 – Photograph of Typical Setup for LC1027 “Arcing Resistance, Direct Effects” Tests, Black Iron Pipe Test Sample

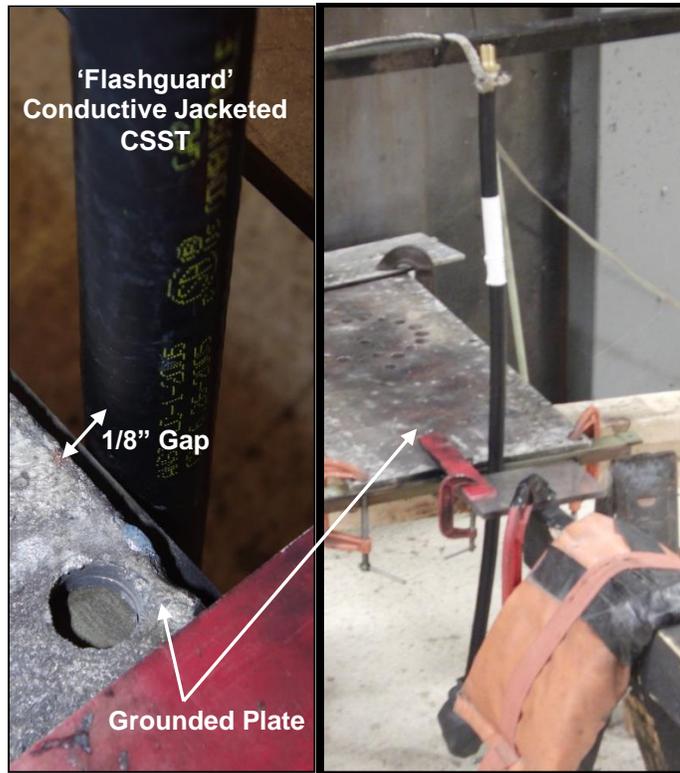
Figure 4 – Photograph of Typical Setup for LC1027 “Arcing Resistance, Direct Effects” Tests, Conductive Jacketed CSST Test Sample

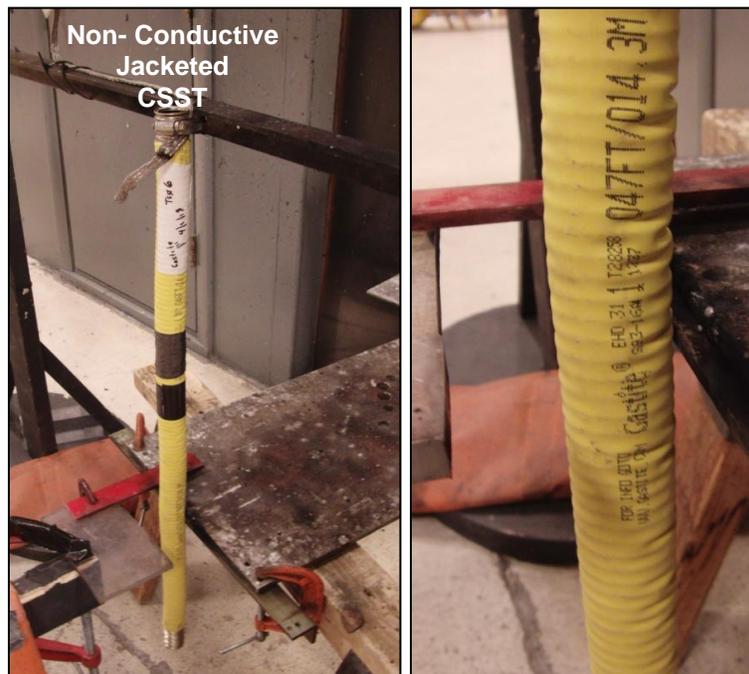
Figure 5 – Photograph of Typical Setup for LC1027 “Arcing Resistance, Direct Effects” Tests, Non-Conductive Jacketed CSST Test Samples

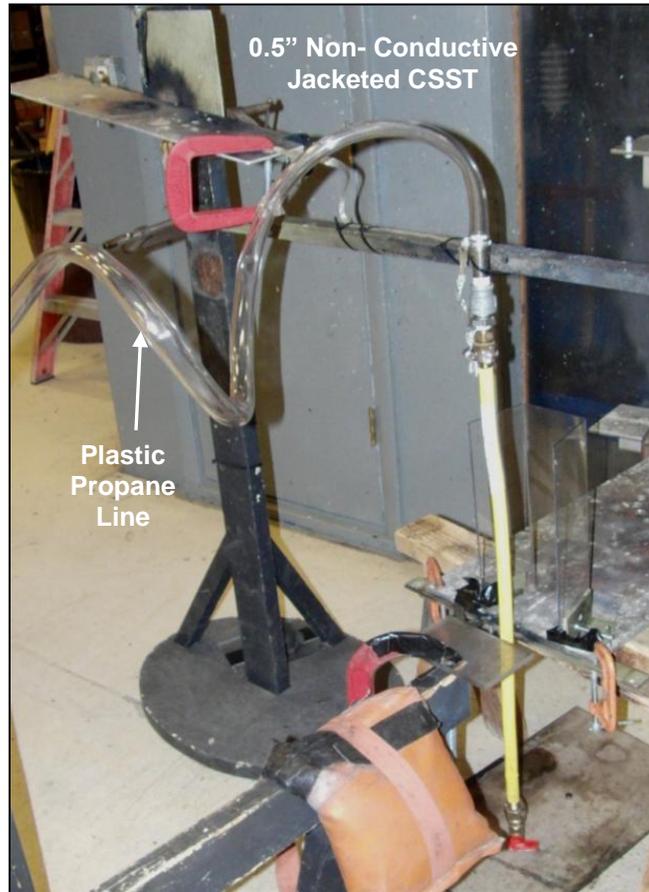
Figure 6 – Photograph of Typical Setup for LC1027 “Arcing Resistance, Direct Effects” Tests, Non-Conductive Jacketed CSST Test Sample using Propane Gas (Not Pressurized)

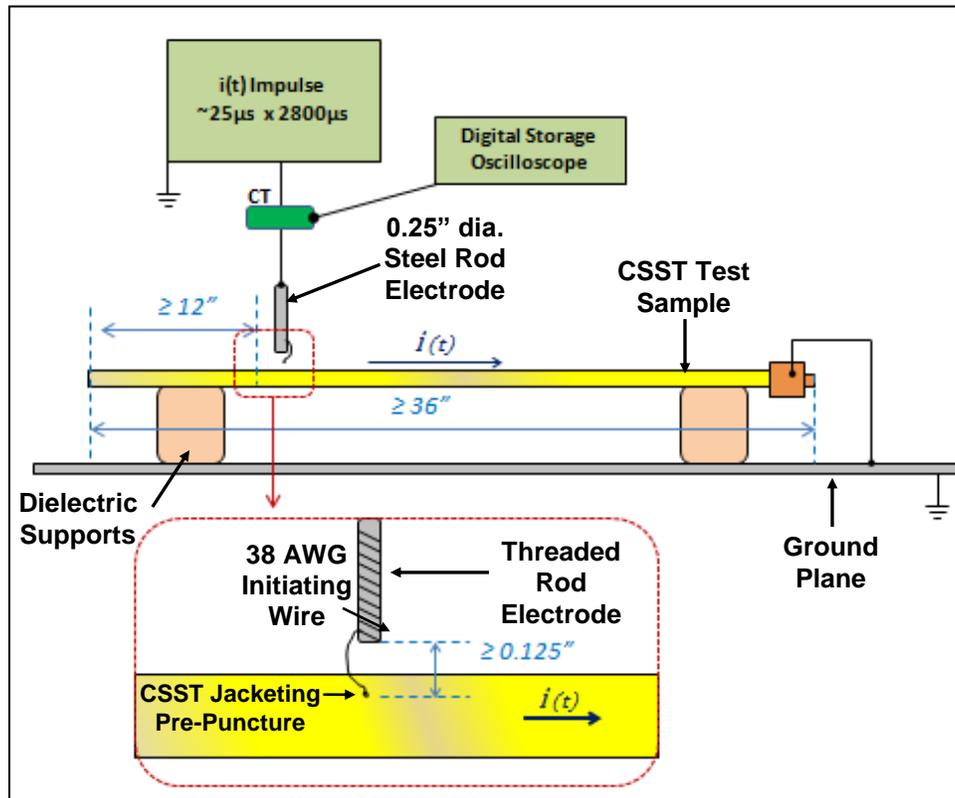
Figure 7 – General Setup Diagram for LC1024 “Arcing Resistance” Tests

The second round of tests performed on the Titeflex, Gastite CSST test samples were the ‘arc resistance’ tests described in LC1024. This setup involves supporting the CSST gas pipe sample with non-conductive supports horizontally above a large flat copper ground plane, which served as the transient generator current return. One end of the gas pipe was connected to this ground plane via a piece of nickel coated copper braid, the other end left open circuit, and the output of the current transient generator connected to a 0.25” diameter, iron rod electrode, positioned to within at least 0.25 inches of the CSST sidewall. The arc is then established between the pipe and the electrode, with ionization of this gap helped by an ‘initiating wire’, a fine gauge filament (~38 AWG) wrapped around the electrode and positioned to within 0.125” of the arc entry location of the pipe sidewall. The free end of this initiating wire was set just above the ‘pre-puncture’ location in the non-conductive jacket of the CSST test sample. Figure 7 shows a basic cartoon of this test arrangement, with Figure 8 showing a photograph of a typical setup for the non-conductive jacketed CSST gas pipe tests. Figure 9 shows a close-up of the rod electrode and initiating wire arrangements for the LC1024 ‘Arc Resistance’ tests.

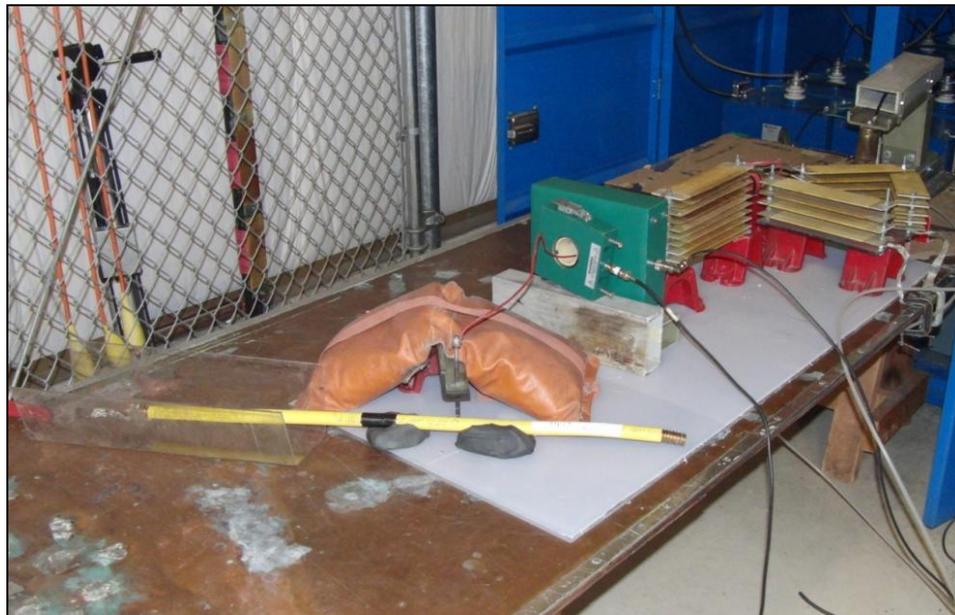
Figure 8 – Photograph of Typical Setup for LC1024 “Arcing Resistance” Tests, Non-Conductive Jacketed CSST Test Samples

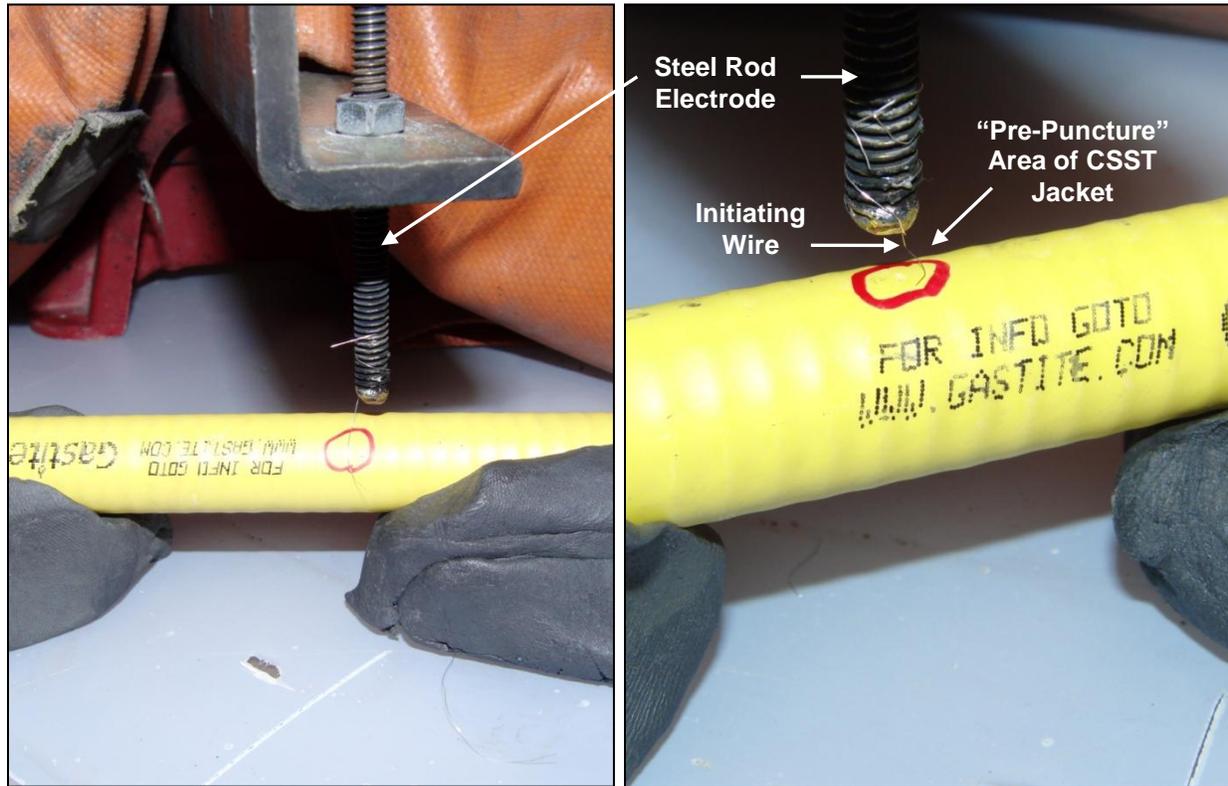
Figure 9 – Photograph of Typical Setup for LC1024 “Arcing Resistance” Tests, Non-Conductive Jacketed CSST Test Samples

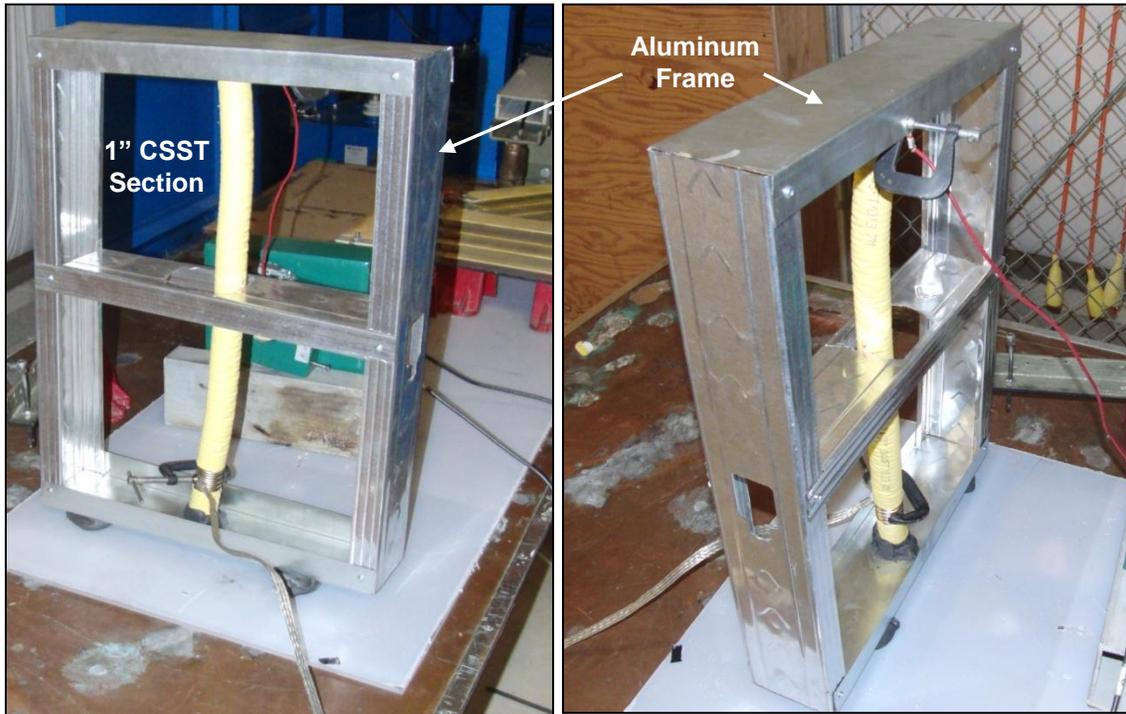
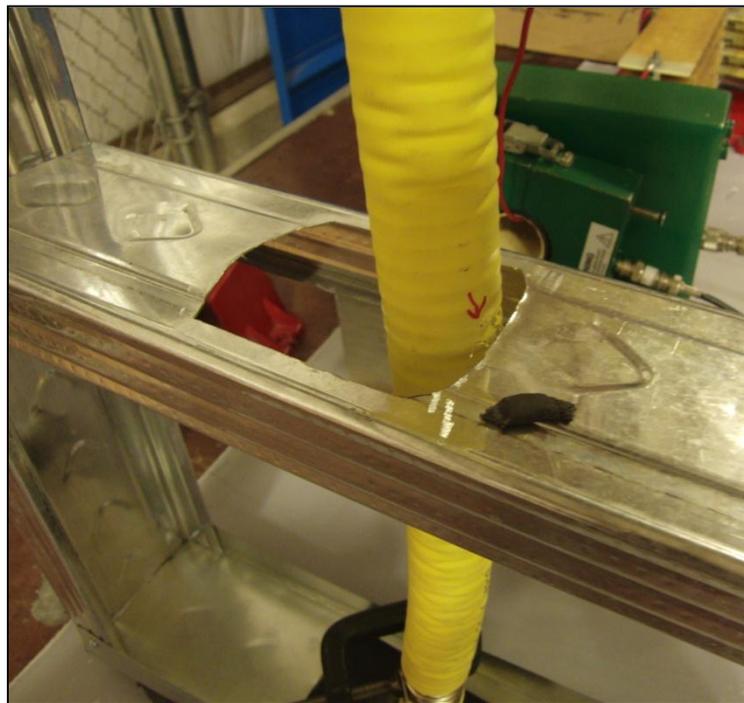
Figure 10 – Photograph of Modified Setup of LC1024 “Arcing Resistance” Test using Aluminum Frame to Non-Conductive Jacketed CSST Gap

Figure 11 – Photograph of Modified Setup of LC1024 “Arcing Resistance” Test using Aluminum Frame to Non-Conductive Jacketed CSST Gap

A derivative of the 'Arc Resistance' test of LC1024 was performed on one, 1.0" sized CSST sample using an aluminum frame lattice in lieu of a rod electrode. This setup involves supporting the CSST gas pipe sample with non-conductive supports vertically above a large flat copper ground plane, which served as the transient generator current return. One end of the gas pipe was connected to this ground plane via a piece of nickel coated copper braid, the other end left open circuit. The aluminum frame was connected to the output of the current transient generator and the CSST test article routed through cutouts in the frame, with a CSST to sidewall separation distance of approximately 0.125 inches. Figures 10 and 11 show photographs from this test arrangement, with the non-conductive jacket being similarly 'pre-punctured' at a point directly opposite the frame cutout.

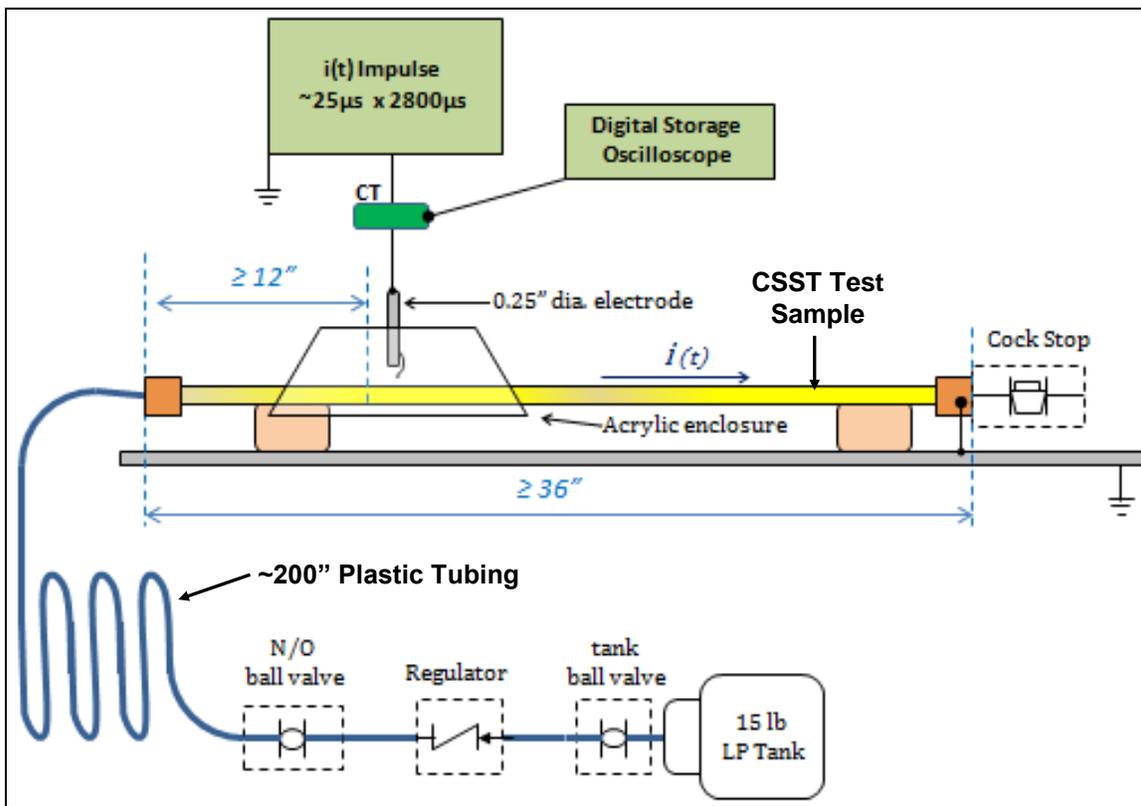
Figure 12 – General Setup Diagram for LC1024 "Arcing Resistance" Tests using Pressurized Propane Gas

The final test performed on the Titeflex CSST test samples per the LC1024 'Arc Resistance' tests was basically the same as described above, with a 0.75" sized CSST gas pipe sample supported horizontally above a large flat copper ground plane, which served as the transient generator current return. One end of the gas pipe was connected to this ground plane via a piece of nickel coated copper braid, this same end being fitted with a shut off stop cock valve to plug this end of the CSST gas pipe. The other electrically open circuit end of the CSST gas pipe was connected to and pressurized by a 15 lb LP tank via a long section of plastic tubing which had an in-line ball shutoff valve (open) and the tank regulator open. The output of the current transient generator was again connected to a 0.25" diameter, iron rod electrode, positioned to within at least 0.25 inches of the CSST sidewall. The arc is then established between the pipe and the electrode, with ionization of this gap helped by an 'initiating wire', a fine gauge filament (~38 AWG) wrapped around the electrode and positioned to within 0.125" of the arc entry location of the pipe sidewall. An Acrylic, three sided enclosure was positioned around the electrode and arc entry area to re-create a loosely confined condition. Figure 12 shows a basic cartoon of this test arrangement, with Figures 13 through 15 showing details of this setup. Figure 16 shows a photograph of the Lyon Associates supplied LP tank and regulator.

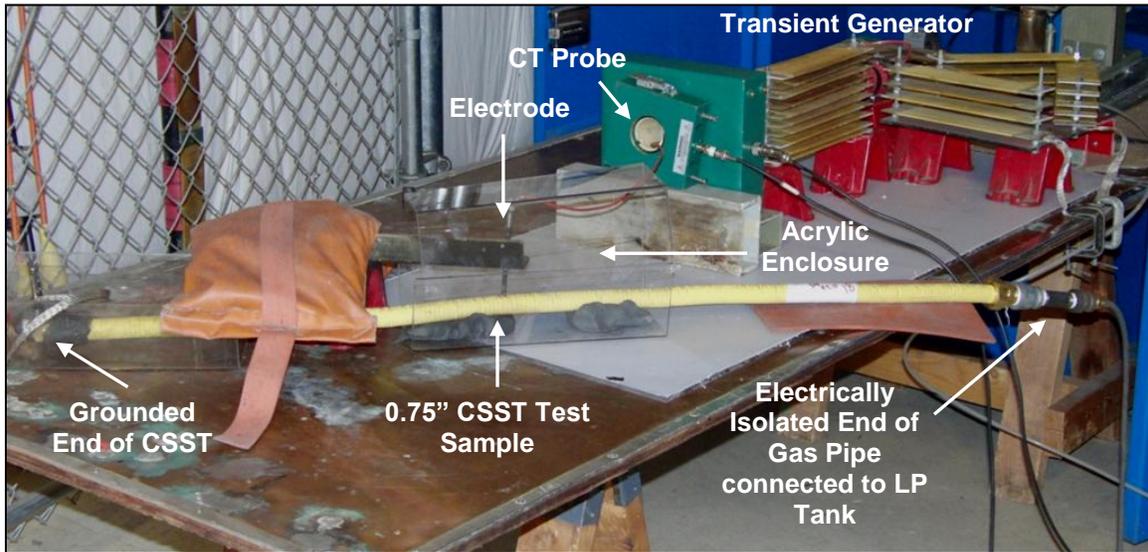
Figure 13 – Photograph of Setup for LC1024 “Arcing Resistance” Test using Pressurized Propane Gas

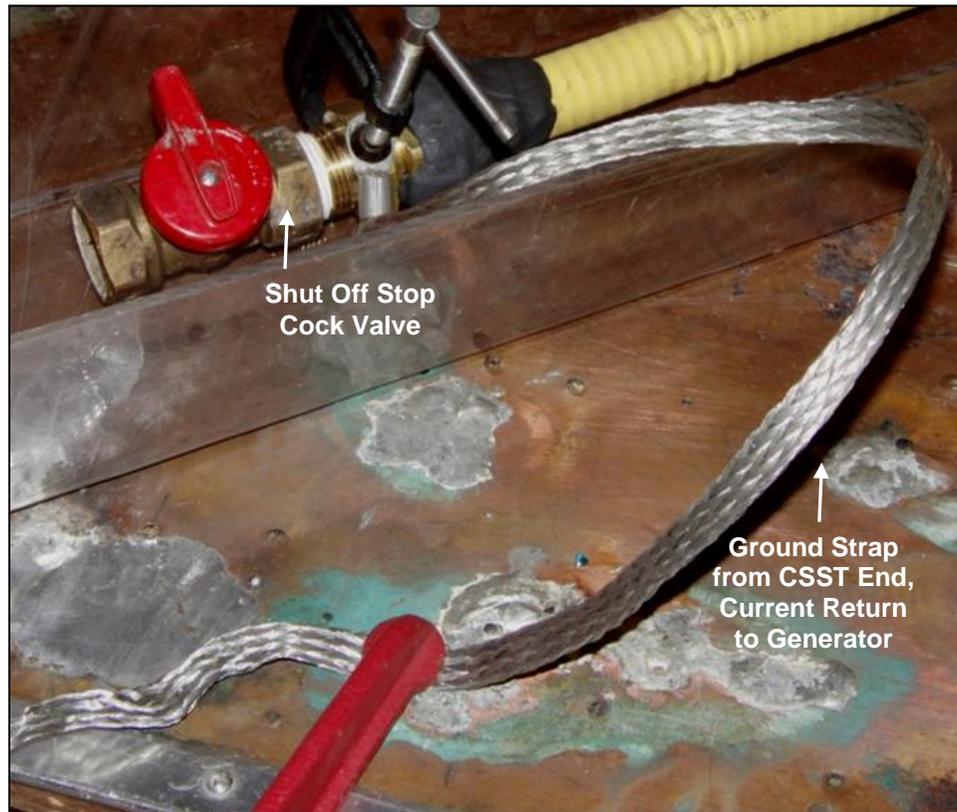
Figure 14 – Photograph of Single CSST Ground Setup for LC1024 “Arcing Resistance” Test using Pressurized Propane Gas

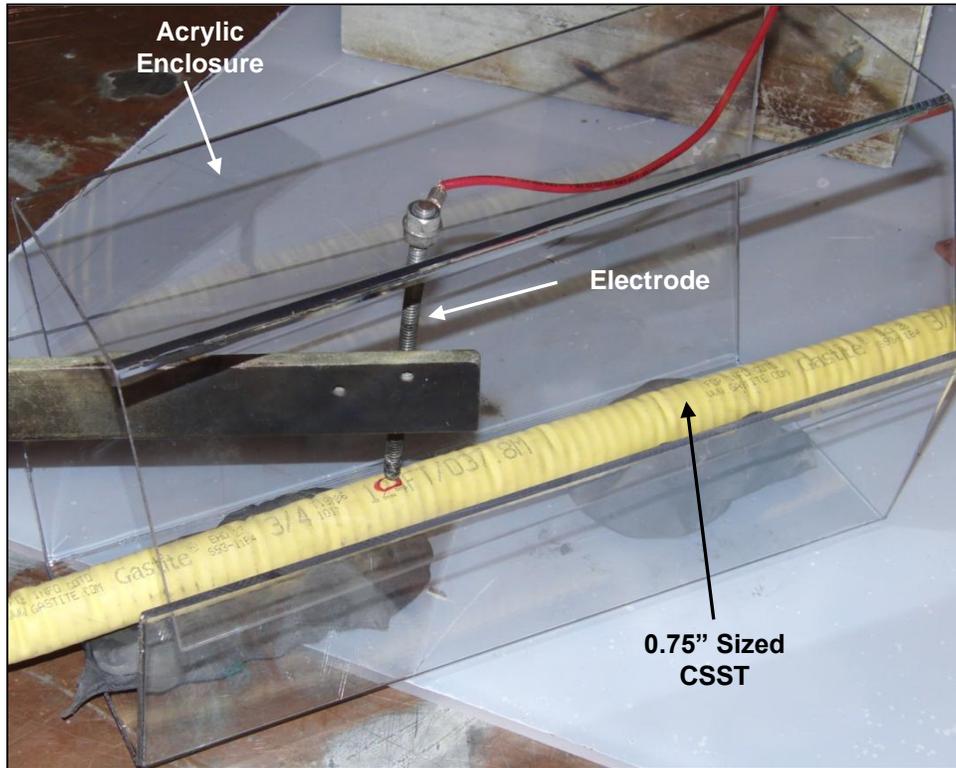
Figure 15 – Photograph of Electrode to CSST Setup for LC1024 “Arcing Resistance” Test using Pressurized Propane Gas

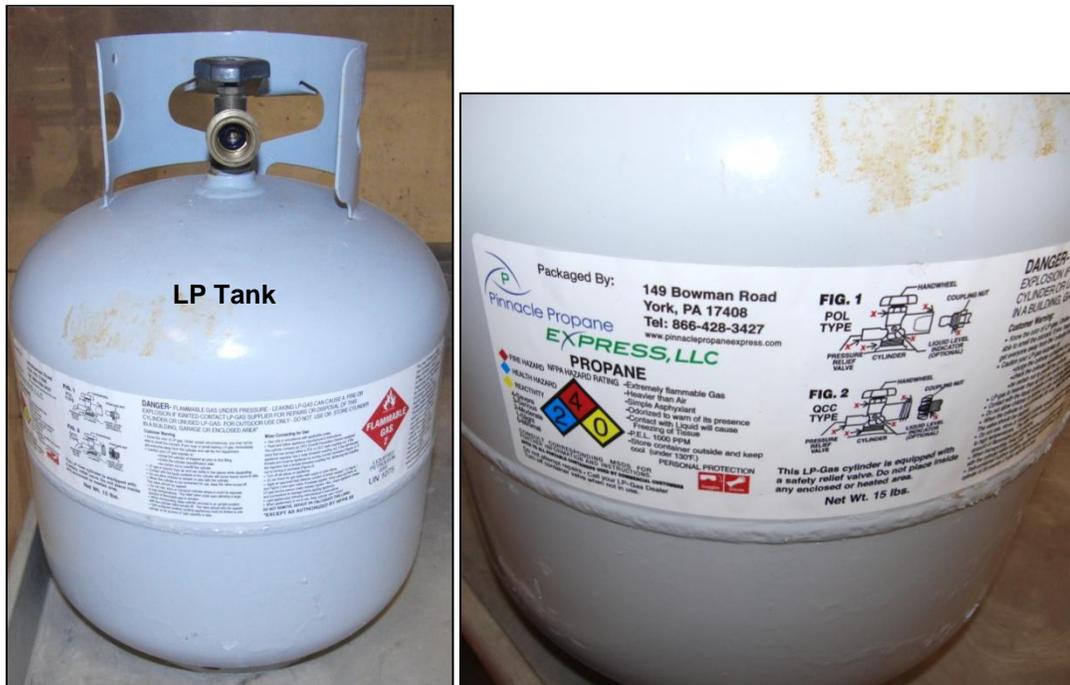
Figure 16 – Photograph of LP Tank Source for LC1024 “Arcing Resistance” Test using Pressurized Propane Gas

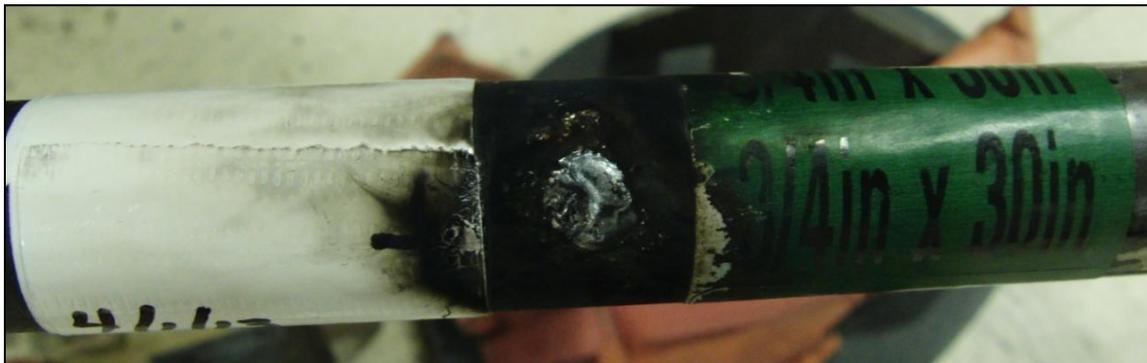
Figure 17 – Post-Test Photograph of Arc Discharge Area on Black Iron Pipe Section, 38.5 Coulombs Total (Test No. 4)

Two 'direct effects' tests were performed on a single 0.76 meter section of black iron pipe (BIP), using Current Components 1, 2, and 3 of Section 4.2.2 of LC1027, with the second test having a modified Current Component 3 delivering 254 Coulombs of charge in lieu of the 26 Coulombs. Both tests resulted in localized surface melting of the iron at the arc entry area but with no punctures or burn-through of the pipe sidewall noted. The tests performed to the black iron pipe test sample did not use propane. Figure 17 shows the result of Test No. 4, with 38.5 Coulombs of total charge deposited to the arc location on the BIP via all three Current Components 1, 2 and 3, each having peak currents of 33.2 kA, 3.9 kA and 562 Amperes average current, respectively. This resulted in a surface melted area of approximately 0.28 inches in diameter. Figure 18 shows the result of Test No. 5, with 267.1 Coulombs of total charge deposited to the arc location on the BIP via all three Current Components 1, 2 and modified 3, each having peak currents of 33.2 kA, 3.9 kA and 550 Amperes average current, respectively. This resulted in a surface melted area of approximately 0.47 inches in diameter.

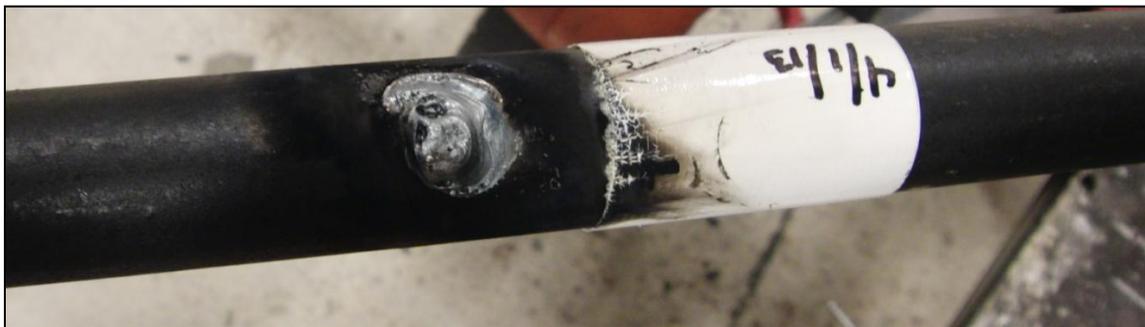
Figure 18 – Post-Test Photograph of Arc Discharge Area on Black Iron Pipe Section, 267.1 Coulombs Total (Test No. 5)

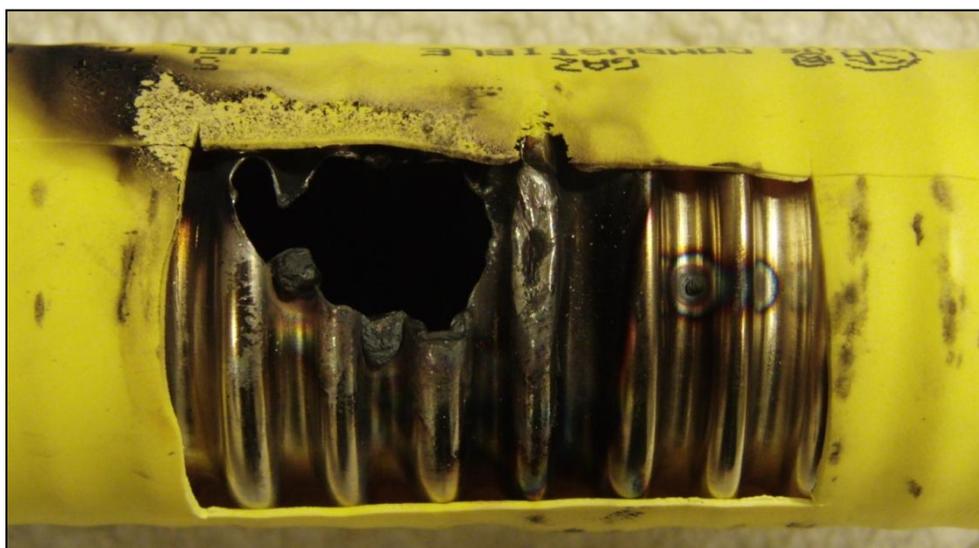
Figure 19 – Post-Test Photograph of Arc Discharge Area on 1.0" sized CSST, 38.8 Coulombs Total (Test No. 6)

Two 'direct effects' tests were performed on 1 meter long, 1.0" sized CSST samples with non-conductive jacketing but with differences in the 'pre-puncturing' method used for the insulating jacket. One sample had a 1" x 1.5" rectangular 'window' cut out of the jacket to expose the CSST metal sidewall, with the other sample having only a pin head sized hole puncture in the jacket opposite the grounded plate electrode. The results observed were a larger burn-through hole in the CSST sample which had the pin hole sized pre-puncture (Test No. 8), with approximately a 0.375" diameter hole in the gas pipe sidewall as compared to a 0.25" diameter hole in the large jacket cutout setup (Test No. 6), both tests having comparable total amounts of charge delivered (41.2 Coulombs and 38.8 Coulombs, respectively). The CSST test sample discharged to the small puncture in the jacket also had visible damage to the pipe sidewall on the side opposite of the arc entry location. Figure 19 shows the post-test results of Test No. 6 (large jacket 'window') and Figure 20 shows the post-test photograph of the CSST from Test No. 8 (small, pin head sized jacket puncture).

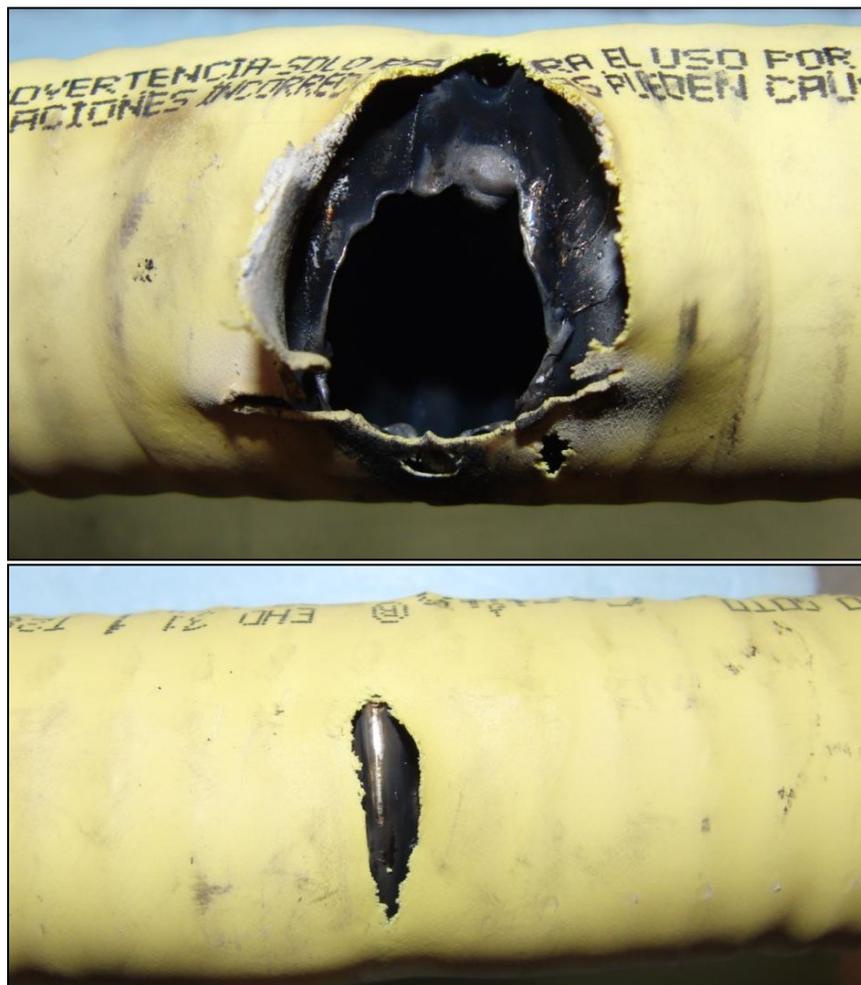
Figure 20 – Post-Test Photograph of Arc Discharge Area on 1.0” sized CSST, 41.2 Coulombs Total (Test No. 8)

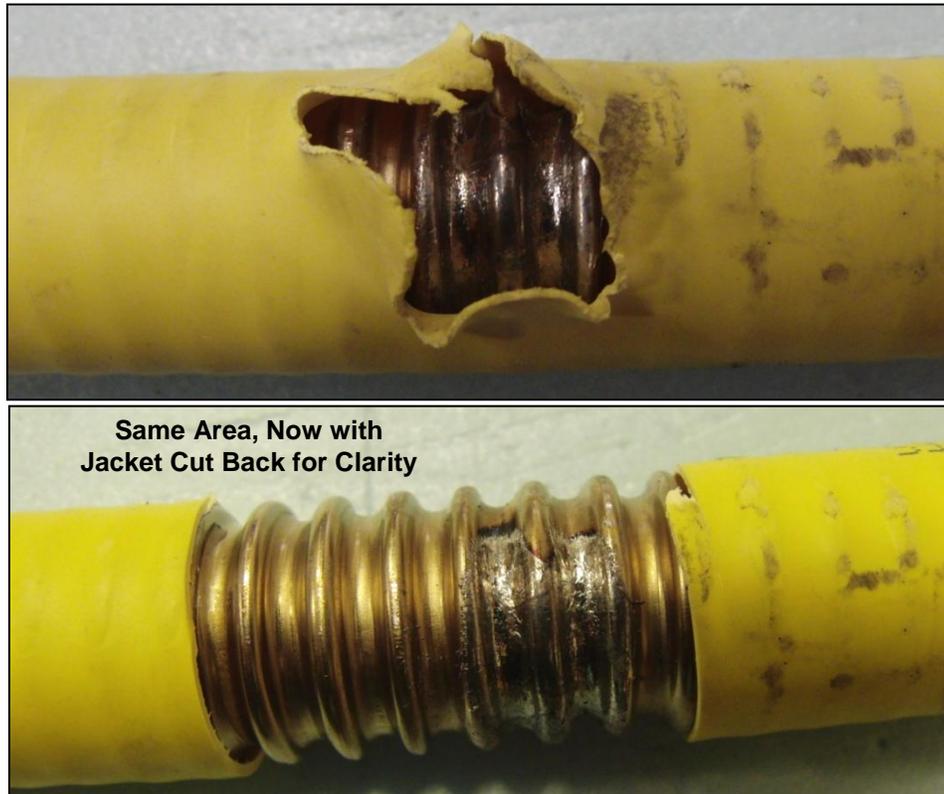
Figure 21 – Post-Test Photograph of Arc Discharge Area on 0.5” sized CSST, 2.86 Coulombs Total (Test No. 9)

A single ‘direct effects’ test applying only Current Component 1 at 32.4 kA peak with 2.86 Coulombs of charge to a non-conductive jacketed, 0.5” sized CSST sample resulted in no visible burn through of the pipe sidewall. This test was performed with propane gas filling the pipe section volume. No flame from the arc discharge was observed. Figure 21 shows the post-test results from Test No. 9, with only the Current Component 1 of LC1027 ‘direct effects’ being discharged to a pre-punctured location in the CSST insulating jacket.

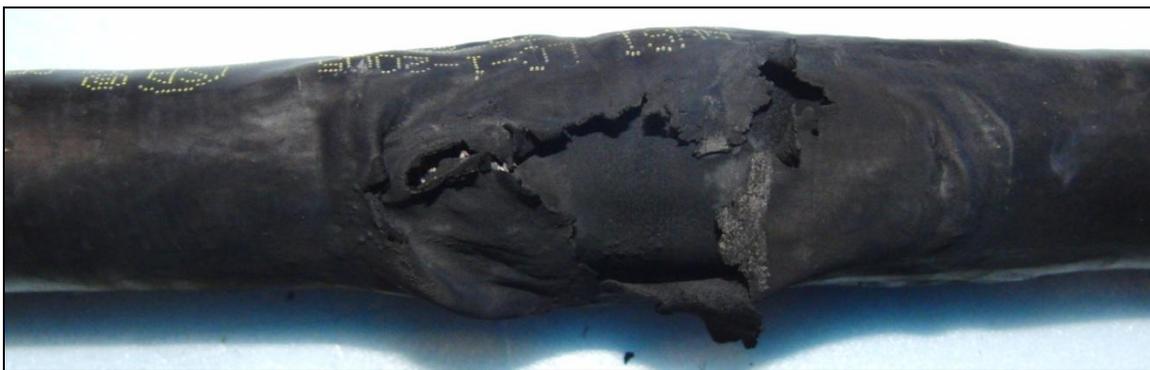
Figure 22 – Post-Test Photograph of Arc Discharge Area on 0.5” sized CSST, Conductive Jacket, 42.9 Coulombs Total (Test No. 7)

A single ‘direct effects’ test applying a total of 42.9 Coulombs of charge to a conductive ‘Flashguard’ jacketed, 0.5” sized CSST sample resulted in localized damage to the jacket at the arc entry area. The jacket was not cut back to observe the condition of the pipe sidewall. This test was performed without using propane gas in the CSST section. Figure 22 shows the post-test results from Test No. 7, with all three current components of LC1027 ‘direct effects’ being discharged to a nominal (non-punctured) location of the CSST conductive jacket.

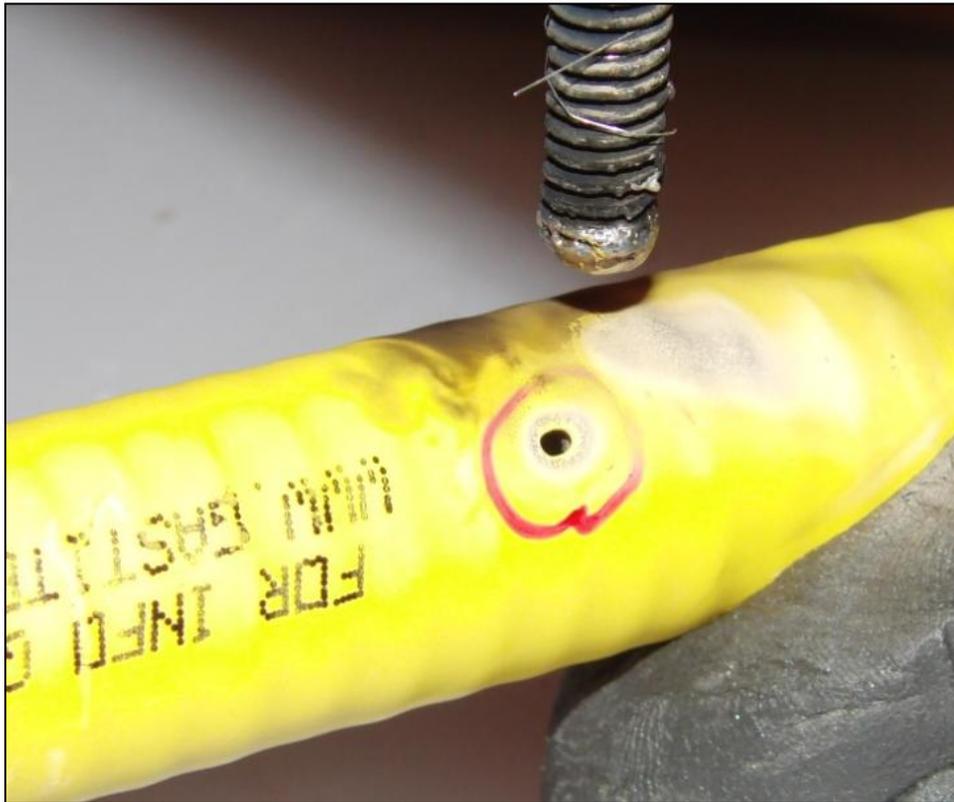
Figure 23 – Post-Test Photograph of Arc Discharge Area on 0.5" sized CSST, Non-Conductive Jacket, 3.62 Coulombs Total (Test No. 12)

The remaining tests utilized the 'Arcing Resistance' test setup of Section 4.3.2.2 of LC1024, using a current transient approximately  $25 \mu\text{s} \times 2,800 \mu\text{s}$  in waveshape. This waveform, at a peak current level of 1.2 kA would deliver 4.5 Coulombs of charge within 2 milliseconds, per Figure 1 of LC1024. The first four tests were performed on 1 meter long, non-conductive jacketed, 0.5" sized CSST sections with progressively lower levels of total charge being deposited. The charge delivered varied from 3.91 Coulombs to 0.76 Coulombs, with all four tests resulting in burn-through of the pipe sidewalls. The resulting holes sizes melted in the sidewalls at the arc entry locations ranged in size from approximately 0.0625 inches to 0.03125 inches in diameter, with the larger hole due to the higher charge transfer. All four of these tests (Test Nos. 12 ~ 15) were performed without any propane gas, using a 'pre-puncture' pin head sized hole in the insulating jacket of the CSST gas pipe at the arc entry locations. A single CSST test article was used for all four tests. Figures 23 through 26 show the post-test photographs from Test Nos. 12 ~ 15, respectively.

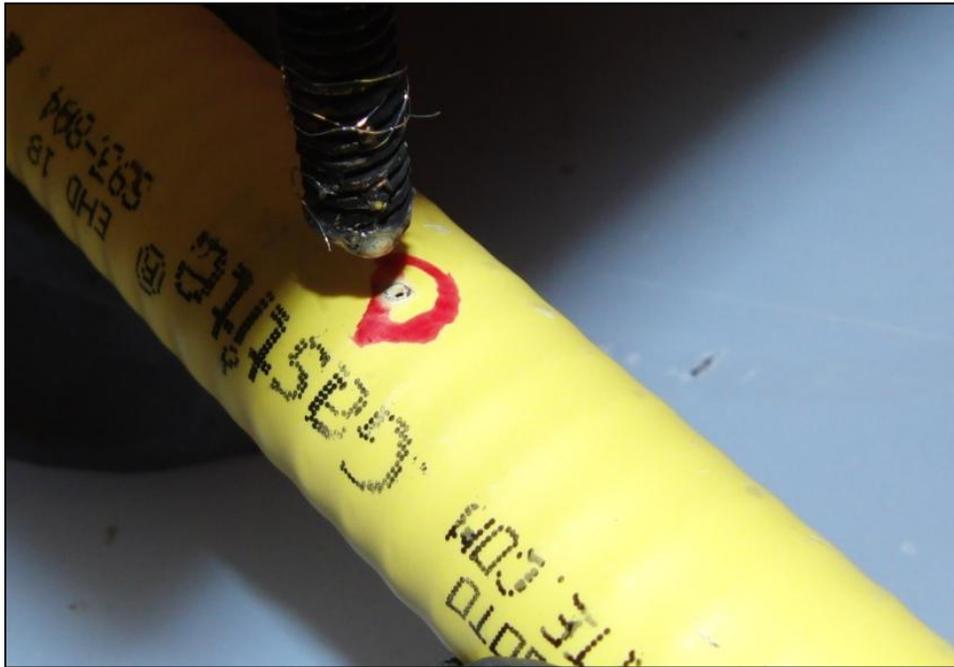
Figure 25 – Post-Test Photograph of Arc Discharge Area on 0.5" sized CSST, Non-Conductive Jacket, 0.77 Coulombs Total (Test No. 14)

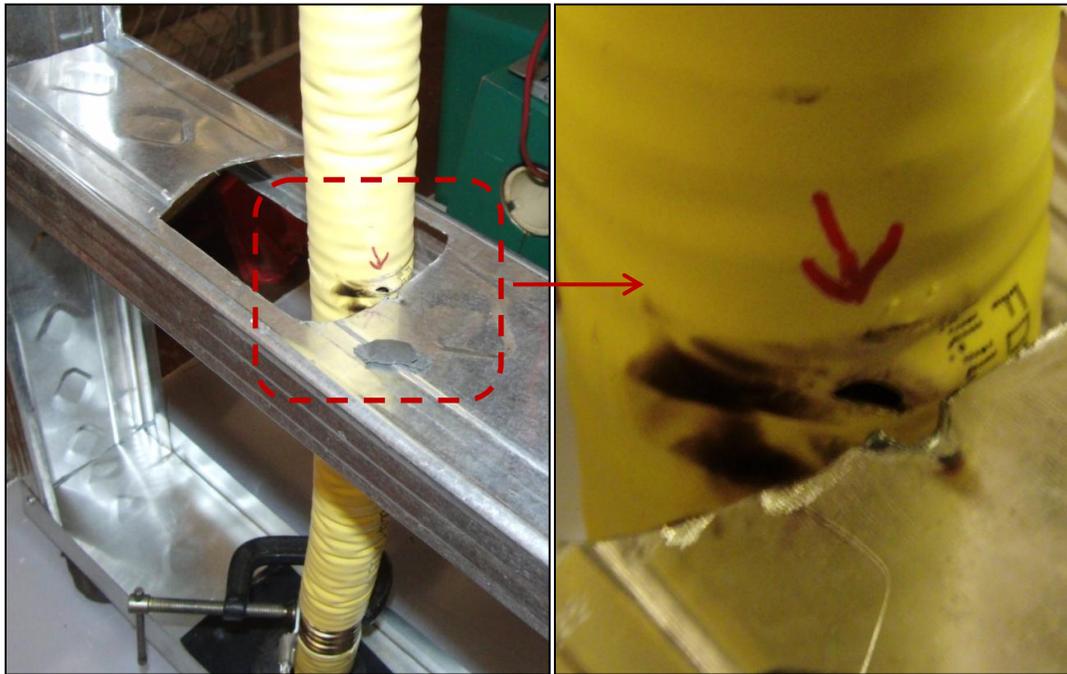
Figure 27 – Post-Test Photograph of Arc Discharge Area on 1.0” sized CSST, Non-Conductive Jacket, 4.69 Coulombs Total (Test No. 17)

A single, 1 meter long, non-conductive jacketed, 1.0” sized CSST, sample was also tested using a steel frame, with the CSST test sample being routed through the frame lattice. The CSST test article had a 1/8” air gap between the jacket and a portion of the steel frame, the frame being connected to the transient generator output and one end of the CSST test sample grounded to the current return of the generator. A total of 4.69 Coulombs of charge was deposited from a 25  $\mu$ s x 2,800  $\mu$ s current transient at 1.22 kA peak, resulting in a 0.25 inch diameter hole in the pipe sidewall. This test (Test No. 17) was also performed without using any propane gas, using a ‘pre-puncture’ pin head sized hole in the insulating jacket of the CSST gas pipe at the arc entry location. Figure 27 shows the post-test photograph from Test No. 17.

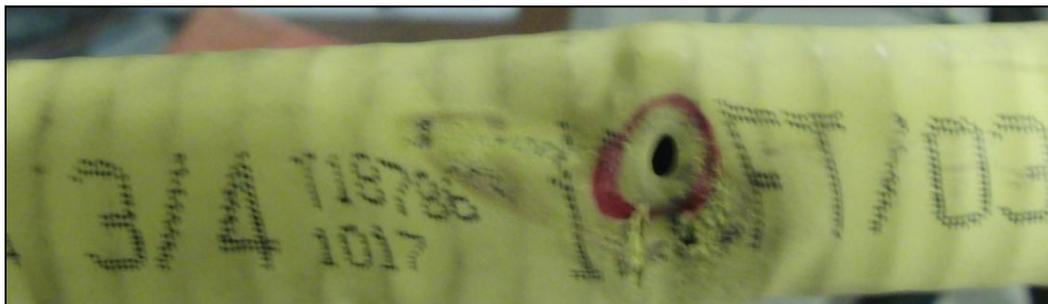
Figure 28 – Post-Test Photograph of Arc Discharge Area on 0.75” sized CSST, Non-Conductive Jacket w/ LP gas, 4.72 Coulombs Total (Test No. 18)

The final test performed was an arc entry discharge per Section 4.3.2.2 of LC1024 to a 1 meter long, non-conductive jacketed, 0.75” sized CSST with the gas pipe pressurized by a remote liquid propane (LP) tank, one end of the gas pipe plugged with a short brass fitting attached to a shut-off ball valve. An acrylic, three sided enclosure approximately 8” x 4” x 4” was placed ovetop of the arc entry test location. The test result was a puncture of the gas pipe sidewall along with an ignition of the exhausting propane gas and continued burning of the gas until the LP tank supply was turned off. Total charge deposited by the 25  $\mu$ s x 2,800  $\mu$ s current transient at 1.22 kA peak was 4.72 Coulombs. Figure 28 shows the post-test photograph from Test No. 18. Figure 29 shows the applied transient current waveform with Figure 30 showing the integral of the applied current transient, or the total charge delivered.

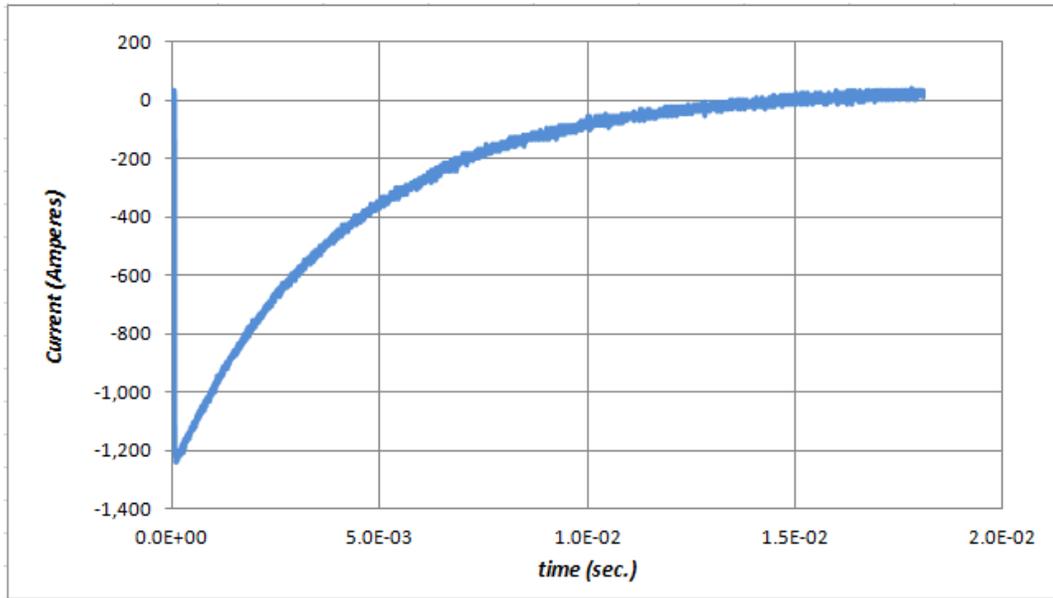
Figure 29 – Applied Current Transient to 0.75” sized CSST, Non-Conductive Jacket with LP Gas, 1.22 kA Peak (Test No. 18)

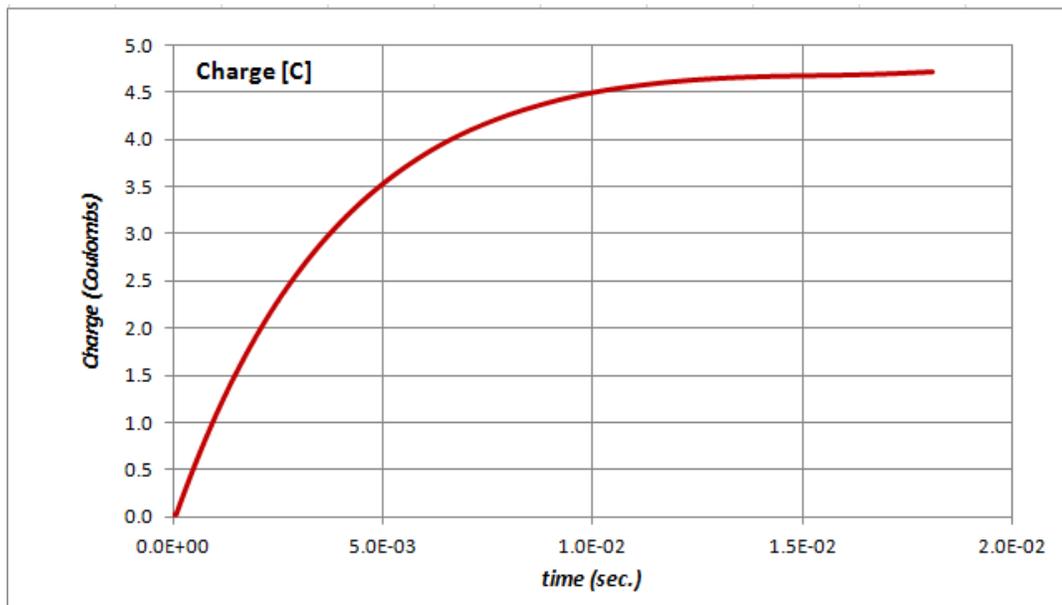
Figure 30 – Total Charge Deposited to 0.75” sized CSST, Non-Conductive Jacket with LP Gas, 4.72 Coulombs (Test No. 18)
